## Winning Windows

A window case study in Astoria, Oregon, shows why repairs are more cost-effective than replacement. We spoke with Joy Sears, restoration specialist at the Oregon State Historic Preservation Office (SHPO), to learn more. **BY DEMETRA APOSPOROS**

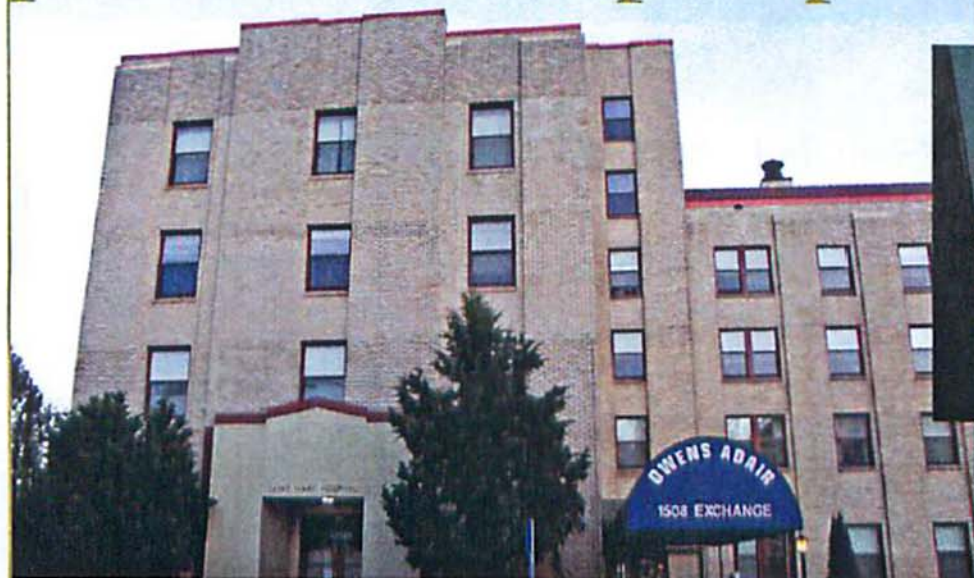
**LEFT:** The building's windows are now good as new; repairing them proved the most cost-effective option. **ABOVE:** Pre-work, the windows were showing significant damage.

**JS:** Because the existing historic window frames were thick enough, they were able to route the sash to accommodate double-paned glass with new glazing. They also replaced the sash cord with a spring balance system with fixed upper sashes, which was less invasive than having to disassemble the original pulleys. And the old storm windows were kept in place during the repairs—so no boarded-up windows.

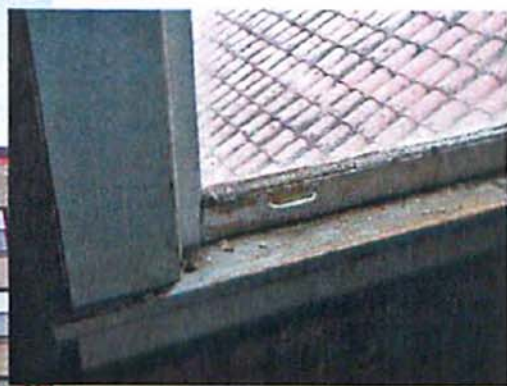
**JS:** They hadn't been well-maintained for decades—they were loose and leaked air, and many had broken sash cords—but they were readily fixable.
